# An *In Vitro* Investigation Concerning the Bacterial Leakage at Implants With Internal Hexagon and Morse Taper Implant-Abutment Connections

**Purpose:** To evaluate, *in vitro*, the leakage observed in internal hexagon and Morse taper implant-abutment connections.

**Key Words:** bacterial contamination, dental implants, implant-abutment connections, microbial leakage

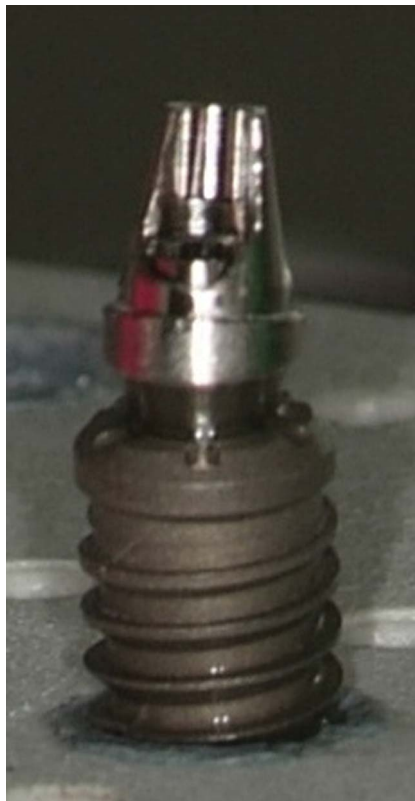
Fig. 1. An assembled implant-abutment after inoculation with a bacterial suspension.

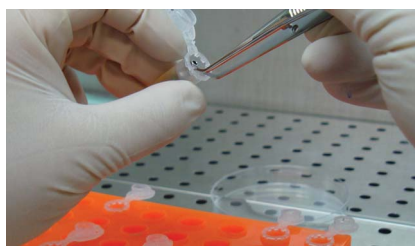
Fig. 2. A Cone Morse taper internal connection placed into nutrient solution.

inside the nutrient solution (NB and TSBY) in a rolling motion for the evaluation of inadvertent contamination of the external surface (Fig. 2). Tubes with a cloudy broth (indicative of colonization/contamination the outer parts of the implant) were excluded from further observation after the evaluation of bacterial growth in plates. Then, the specimens were placed into sterile Eppendorf tubes (Eppendorf, Milan, Italy), and the volume of nutrient solution required in the test vials was determined exactly for each implant system, so that the fluid level remained just above the implant-abutment interfaces. All the vials containing the assemblies, the test tubes used as external contamination control, the test tubes used as positive control, and the test tubes used as negative control were incubated at 37°C, under aerobic condition for PS and 37°C in presence of 5% CO<sub>2</sub> for AA. They were maintained for 28 days, and the culture broth in the vials containing the assemblies were replaced every 7 days. The possible penetration of bacterial suspension into the surrounding solution was determined by the observation of turbidity of the broth. The samples were checked daily, and the presence or absence of turbidity was recorded (Fig. 3). Such leakage caused bacterial colonization and resulted in a cloudy solution; 1 µL of the solution was analyzed with a Gram stain and by colony morphology in cetrimide agar (Oxoid, Ltd) or in tryptic soy agar yeast plates (Oxoid, Ltd), incubated at 37°C for 24 hours (48 hours for AA) to confirm the purity of the microorganism that had been inoculated in the inner part of the implant and determining the

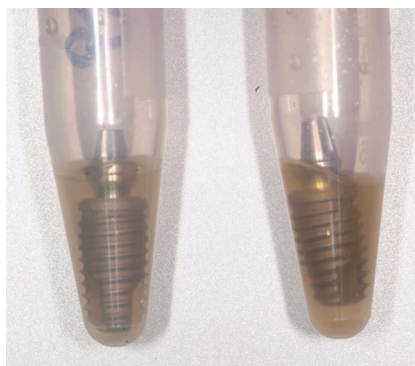
Fig. 3. Left: no contamination. Right: turbidity of the broth as a sign of bacterial penetration.
